Containing Risk: Climate Data and Phase I ESAs - A Case Study of ASTs in High Flood Risk Regions

By: Victor DeTroy, AEI Consultants

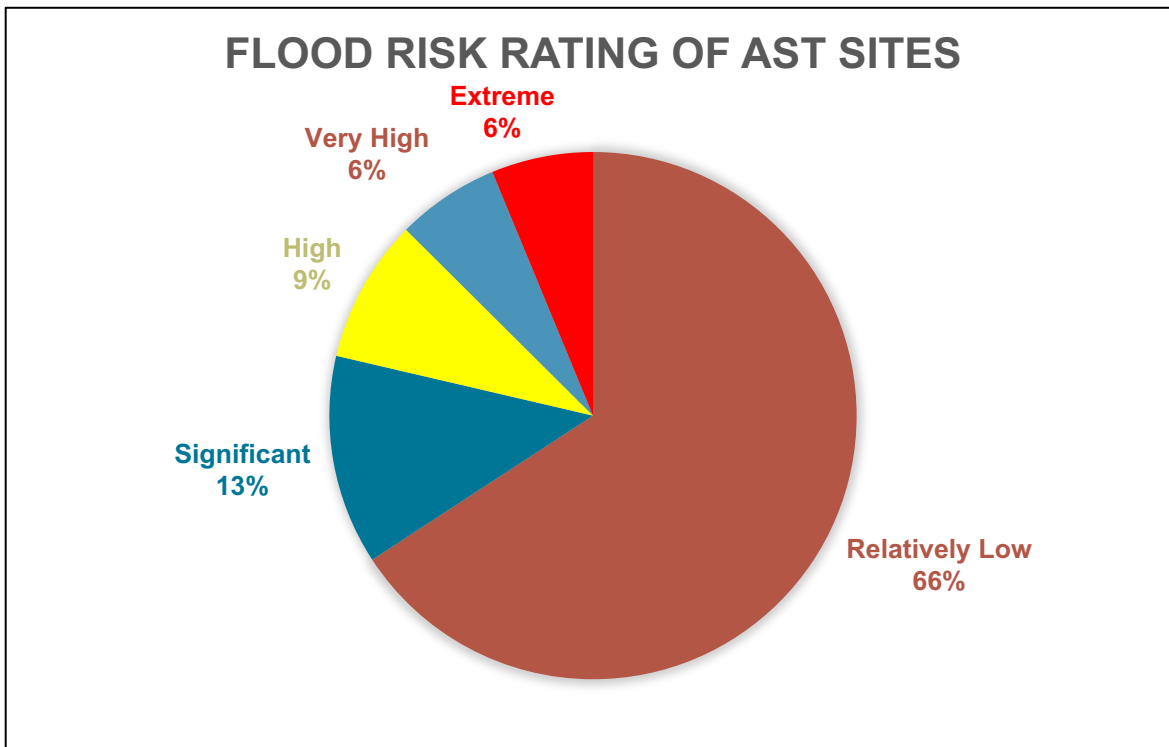
Chart 1: Pie Chart of the breakdown of the flood risk rating of the 26,303 AST sites

Chart 1: Pie Chart of the breakdown of the flood risk rating of the 26,303 AST sites.

A majority of the listed AST sites were identified to be “relatively low” flood risks. However, approximately 21% of sites (5,617 of the total 26,303 sites) were located in areas of high to extreme flood risk. Approximately 13% of sites (3,300 of the total 26,303 sites) were in areas of very high to extreme flood risk. Approximately 6% of sites (1,640 of the total 26,303 sites) were in areas of extreme flood risk.

This suggests that more than 1 in 5 sites with permitted ASTs are in elevated flood risk areas. This is a number that should raise the eyebrows of environmental professionals. As our climate continues to evolve, the danger of an AST being damaged by a flood may no longer be considered a remote possibility.

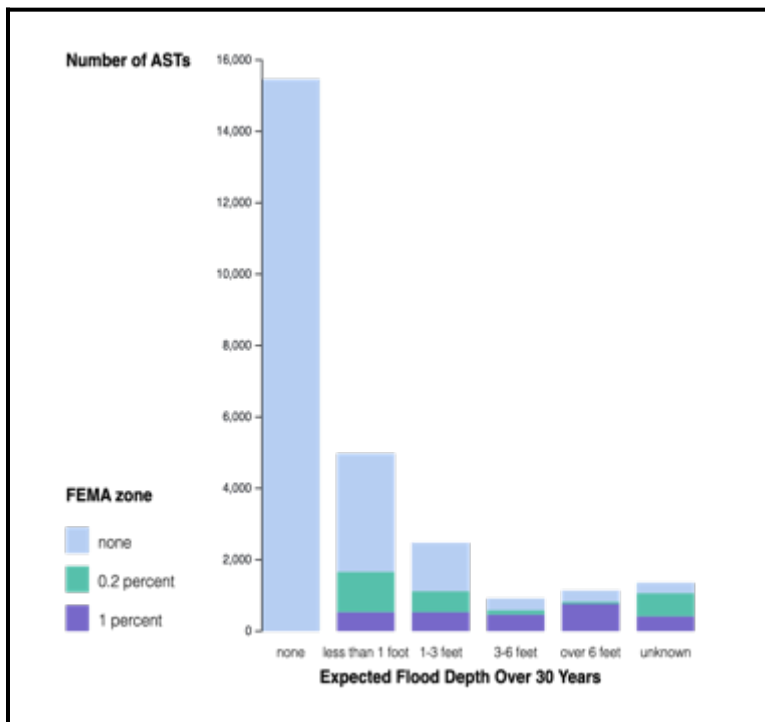
Chart 2: Distribution of the expected depth of a flood at the locations over 30 years (a graphical representation of Table 1).

Table 1 and Chart 2 give us some insight into probable flood depths. From an environmental professional’s perspective, the risk of a flood less than one foot may not be much of a concern for a site where hazardous substances are properly stored in elevated secondary containment. However, at a site with poor housekeeping (including various stained areas and corroded containers stored on bare soil), a one-foot flood may present a much higher risk. For a site with an AST, depending on the configuration of the AST, an environmental professional may consider any flood below three feet to be a fairly limited hazard.

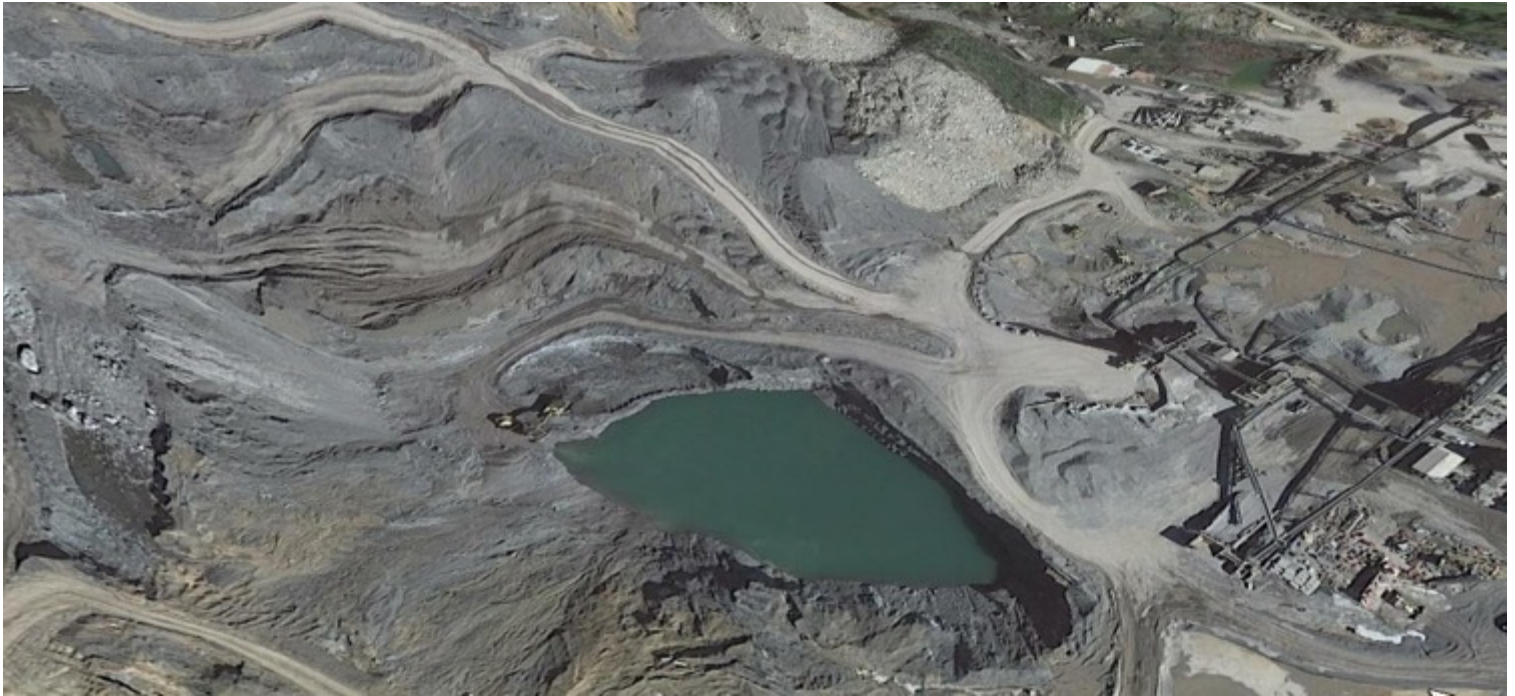
In our second case study, Flood Rock Quarry (not its real name) is in Sonoma County, California, and consists of a steep hill stripped of vegetation. Three 1,000-gallon diesel ASTs and approximately 30 drums (containing waste oil and solvents) are situated at the base of the hill. ASTs and drums are on a concrete pad, but no berms or concrete walls enclose the area.

The property is not in a FEMA flood zone; nevertheless, given the location next to a creek and steep elevation disparity, it is given a flood score of 100 (extreme flood risk; see Graphic 1). The fact that the steep hill is stripped of vegetation compounds the potential risk of flash floods during extreme precipitation. A retention pond is present; however, the water appears to be at grade and at risk of overflowing into the yard area.

Hypothetical: During a Phase I ESA at this property, a field assessor observed leaking valves and piping from all three ASTs, and small amounts of product appeared to be pooling at the base of the tanks. However, the product is confined to the underlying concrete pad and does not extend onto surrounding soils. Drums appear to be rusted and are stored directly on concrete with no secondary containment; no leaks were noted at the base of the drums. Nearly half of the drums do not have lids, and the lids on the remaining drums do not appear to be tightly fastened.
